## FIRE PROTECTION SYSTEM ASSESSMENT OF RETER CAFÉ BUILDINGS IN YOGYAKARTA

**ABSTRACT:** Fire hazard is a problem that often occurs due to lack of good facility protection. Fire incidents in commercial high-rise buildings can be used as a benchmark to reduce fire risk. A good fire system can prevent fires, reduce damage, and carry out a good evacuation. Cafe is a commercial building that has safety standards for its residents. One form of protection is to protect against fire hazards. This research was conducted at Caffé Reter which is located on Pandega Marta Street, Pogung Kidul, Sinduadi, Mlati district, Sleman Regency, Special Region of Yogyakarta. This study aims to assess the completeness of the fire protection system facilities and infrastructure available at Caffé Reter. The method used is the process of observing and evaluating 4 parameters of the reliability of the building safety system, namely site completeness, rescue equipment, active protection and passive protection with reference to the Regulation of the Minister of Public Works Number 26/PRT/M/2008. The result of the reliability of the Building Safety System is 78.05 which means the reliability value of Caffé Ret

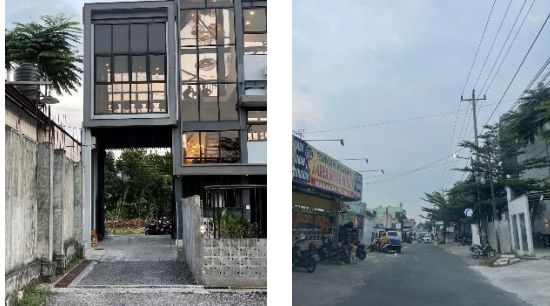
**Figure 1** Road Pavement

According to SNI 03-1735 and 1736-2000, there are several criteria that must be met in determining building scores on neighborhood roads. One of them is that the width of the road must be at least 6 meters, and the width of the driveway must be at least 4 meters and must be paved. At the Café, the environmental road is on the west side of the building with a width of 4 m, on the south side of the building there is a parking area with an area of 22 x 21 m with pavement in the form of soil coated with gravel, and the main road with a width of 7 m and everything has been paved.

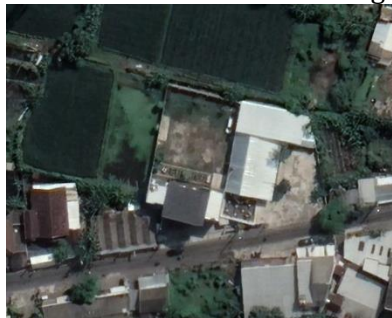
**Figure 2** Location Plan

In an effort to protect against the spread of fire, the minimum distance between buildings is determined. The north side has no settlements/shops. The east side is still vacant land, but there are shops with one floor located in the building yard that are not directly adjacent to the building. The south side is a parking area with an area of 22 x 21 m and there are no buildings after the parking area. The west side is adjacent to the Bento Coffe café yard.
